CONSTRUCTION STORMWATER GENERAL PERMIT INSPECTION REPORT

State of Washington Department of Ecology

The Electron Hydro LLC Intake project is covered under the State of Washington's Construction Stormwater General Permit (CSWGP). The CSWGP is a National Pollutant Discharge Elimination System (NPDES) and a State Waste Discharge permit for discharge of construction-related stormwater. The purpose of this inspection was to conduct a compliance inspection with Ecology's new staff, Evan Wood, to provide technical assistance as appropriate, and to continue to make site observations and have discussions regarding the water quality management plan (WQMP). The settling basin and forebay/laydown areas were also viewed, which are not within or near the CSWGP site, but has implications related to hydro operations and sediment management. Follow-up is occurring outside of the CSWGP.

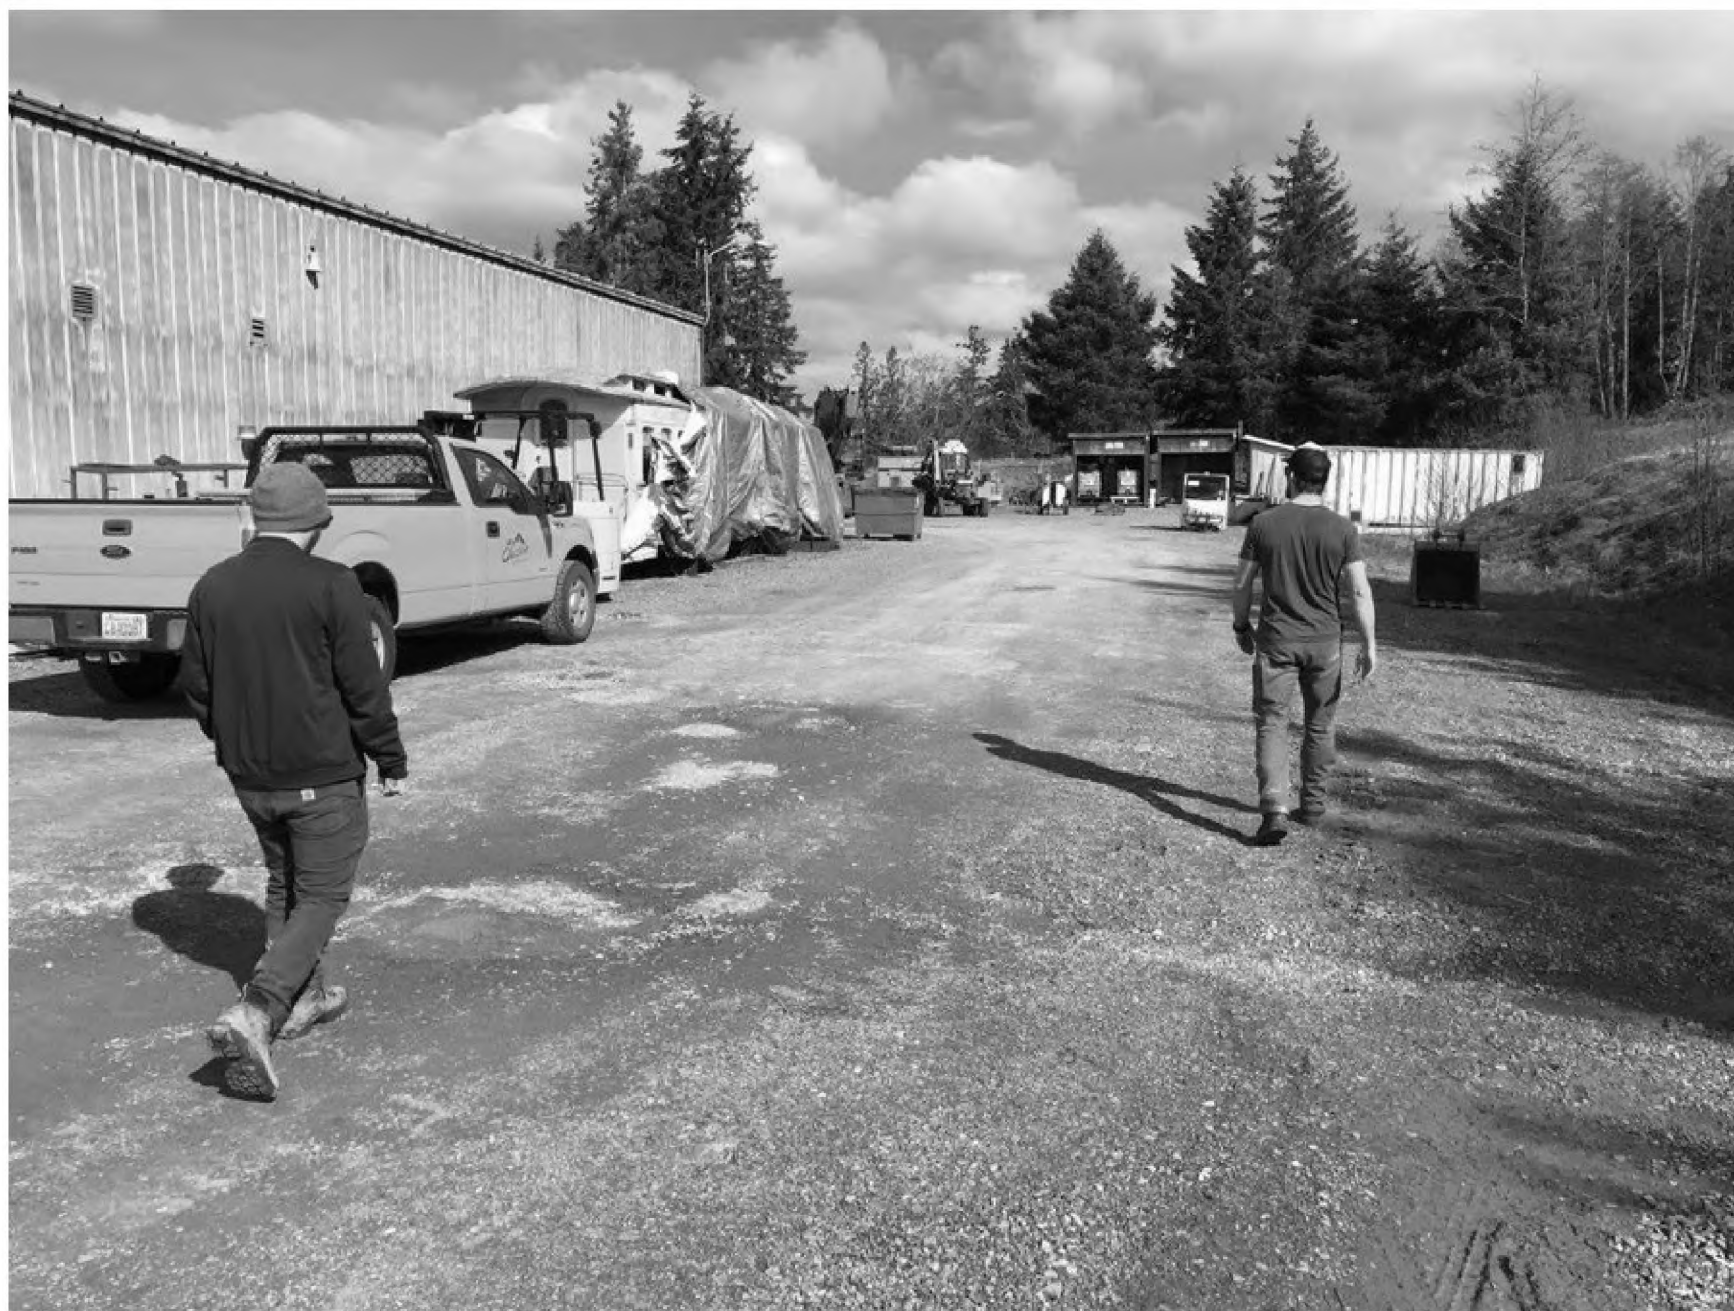
Photo 20

Photo Description: Forebay area - Maintenance shed -. We were following a conveyance flowing along under the white storage container and along the bottom of the hill in the (right of the photograph).

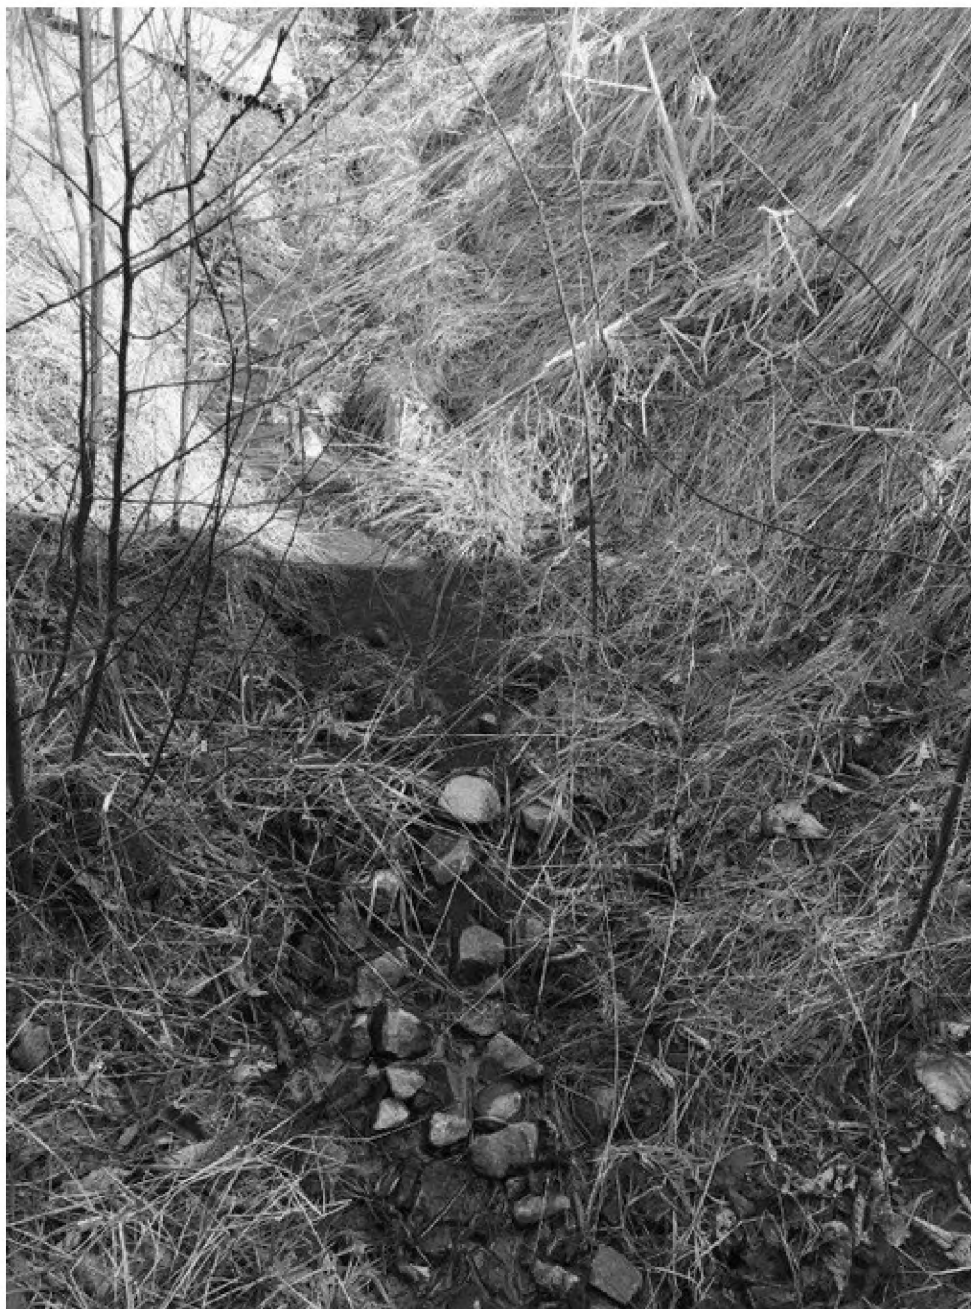
Photo 21

Photo Description: Forebay area - Maintenance shed - Conveyance/drainage alongside the Maintenance Shed and fuel storage area. There were no orange biofilms along this conveyance. This conveyance leads to an underground connection with an oil water separator before discharging into the Forebay.

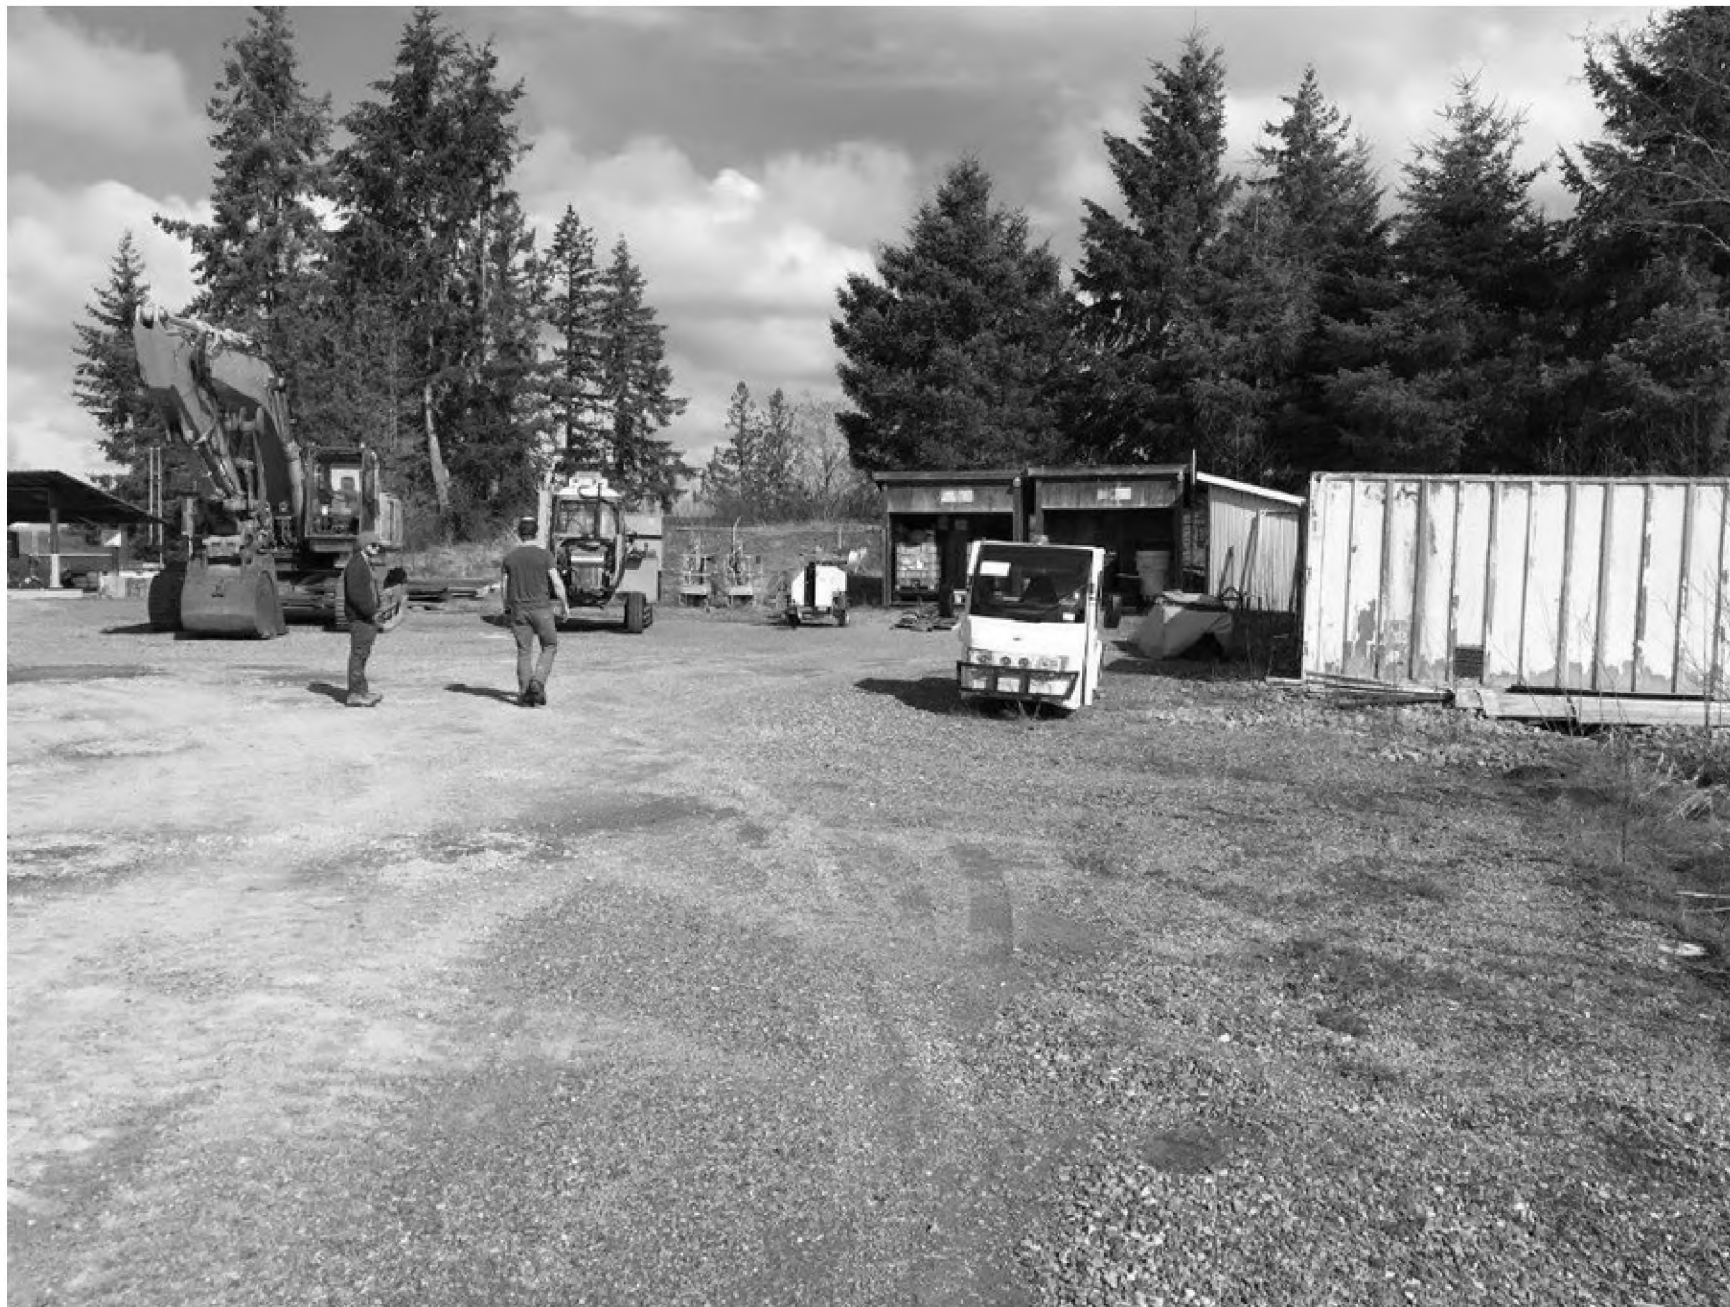
Photo 22

Photo Description: Forebay area - Maintenance shed area

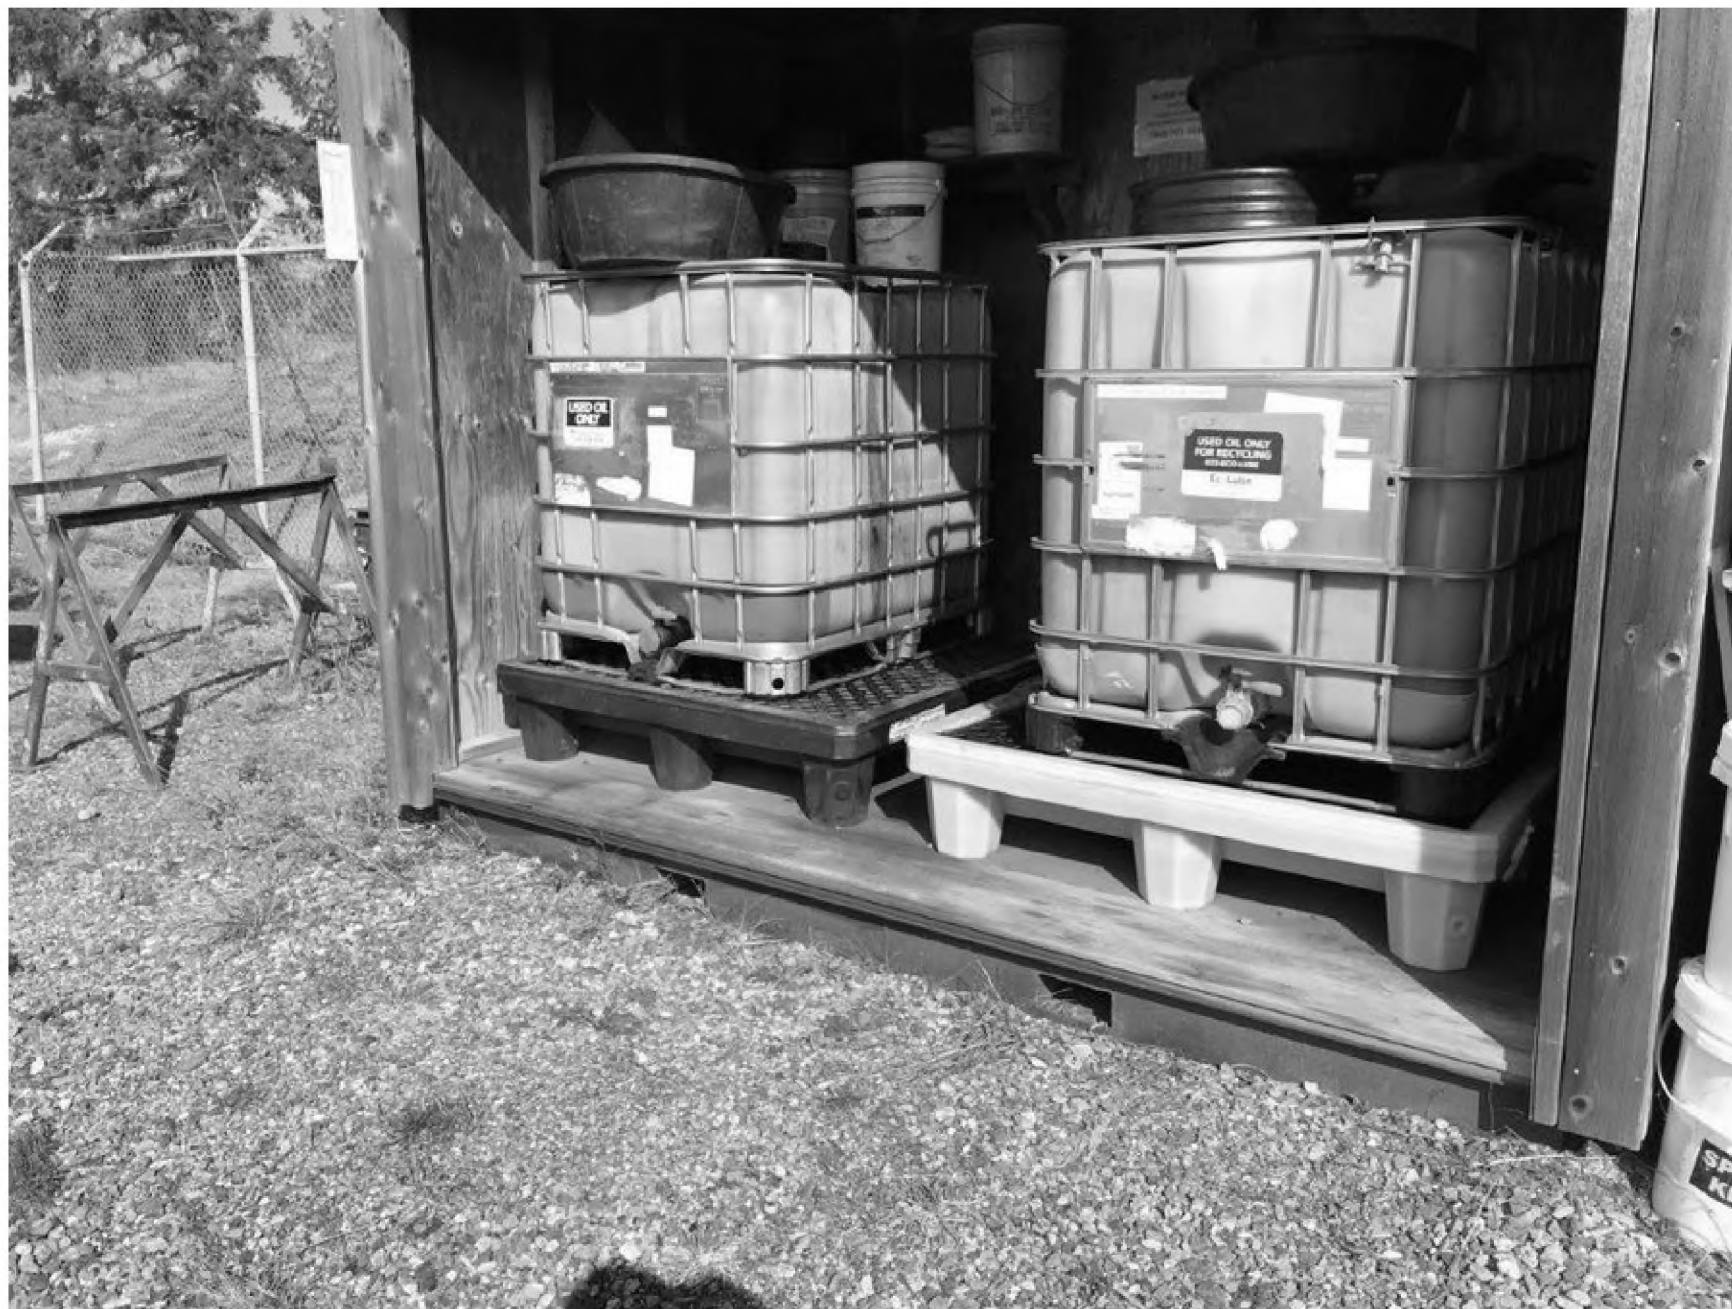
Photo 23

Photo Description: Forebay area - fuel storage shed

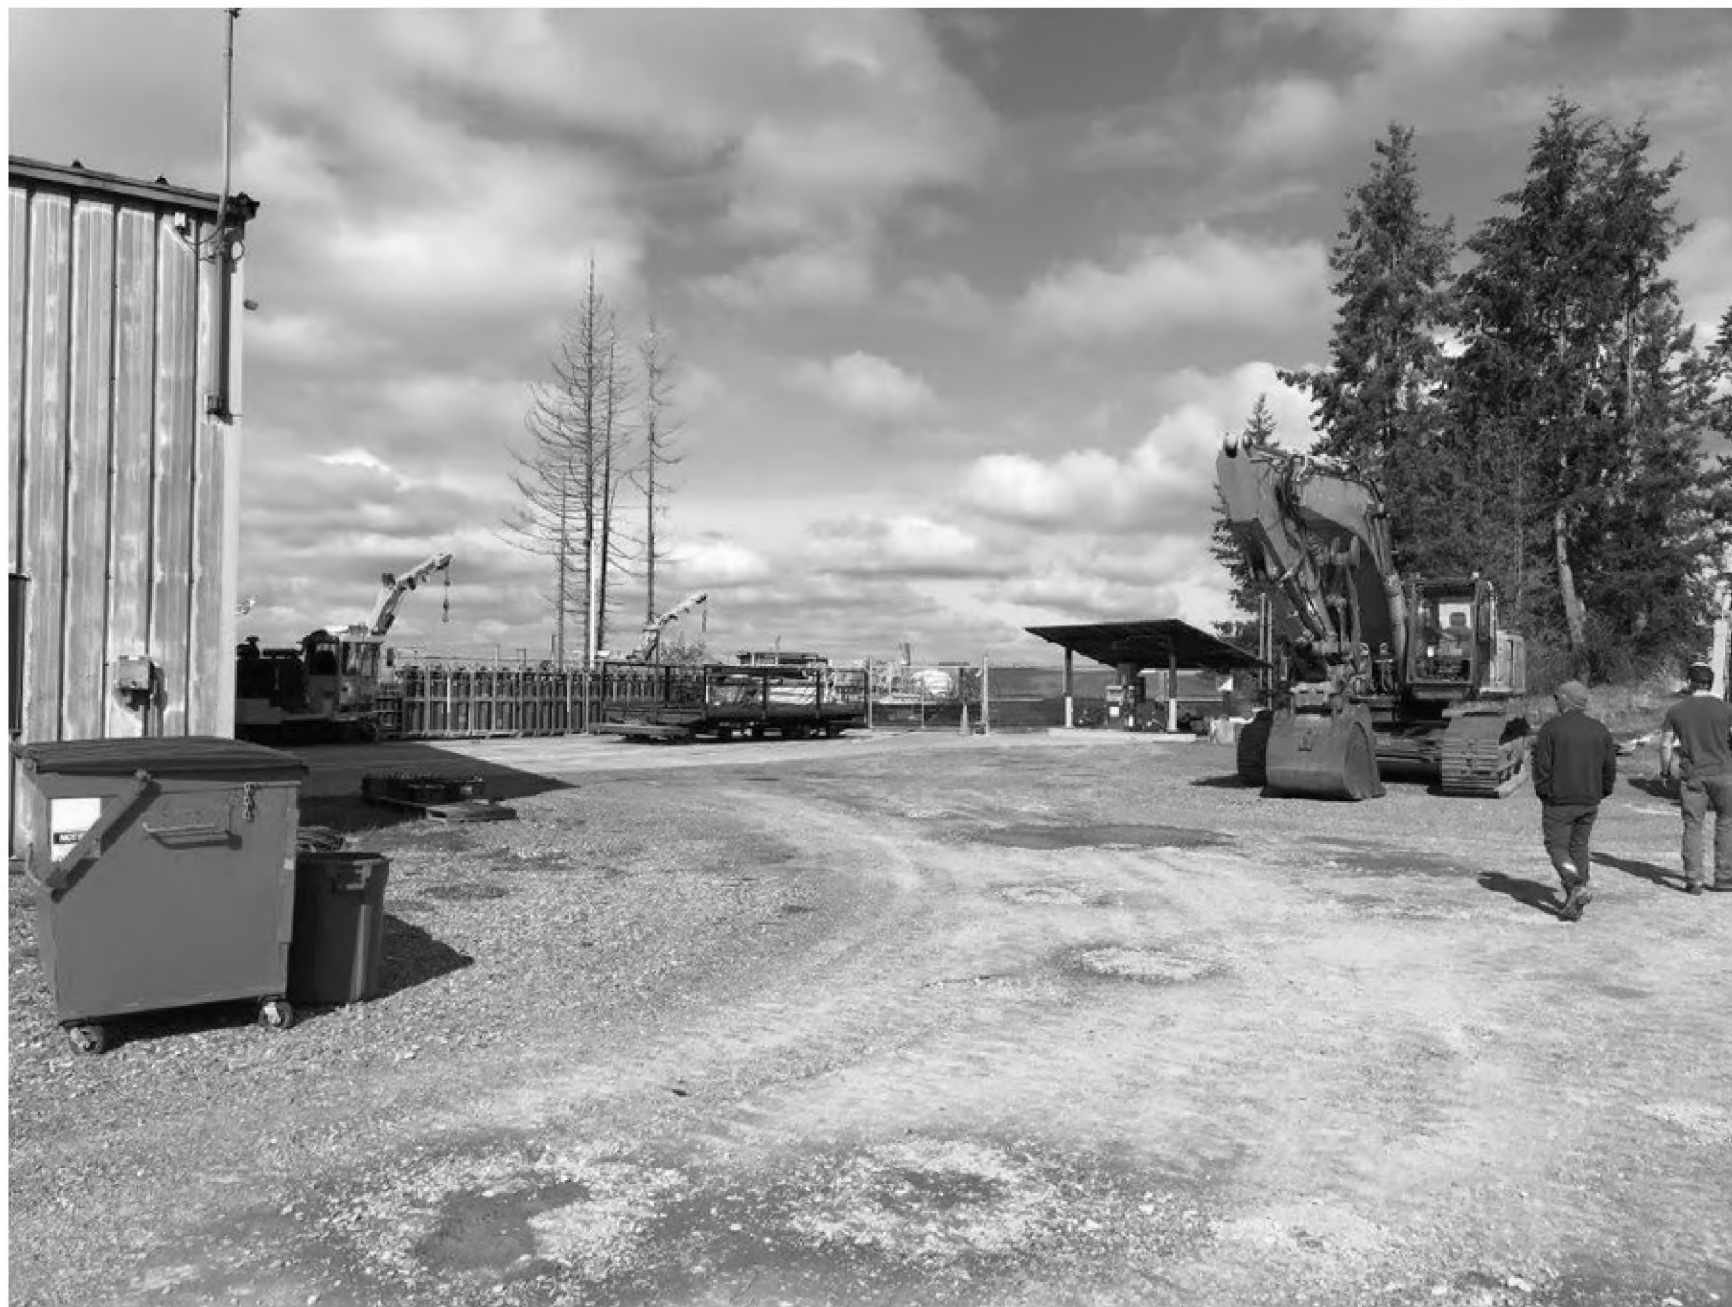
Photo 24

Photo Description: Forebay area - Maintenance shed - Underground Fuel storage area (center of photo)

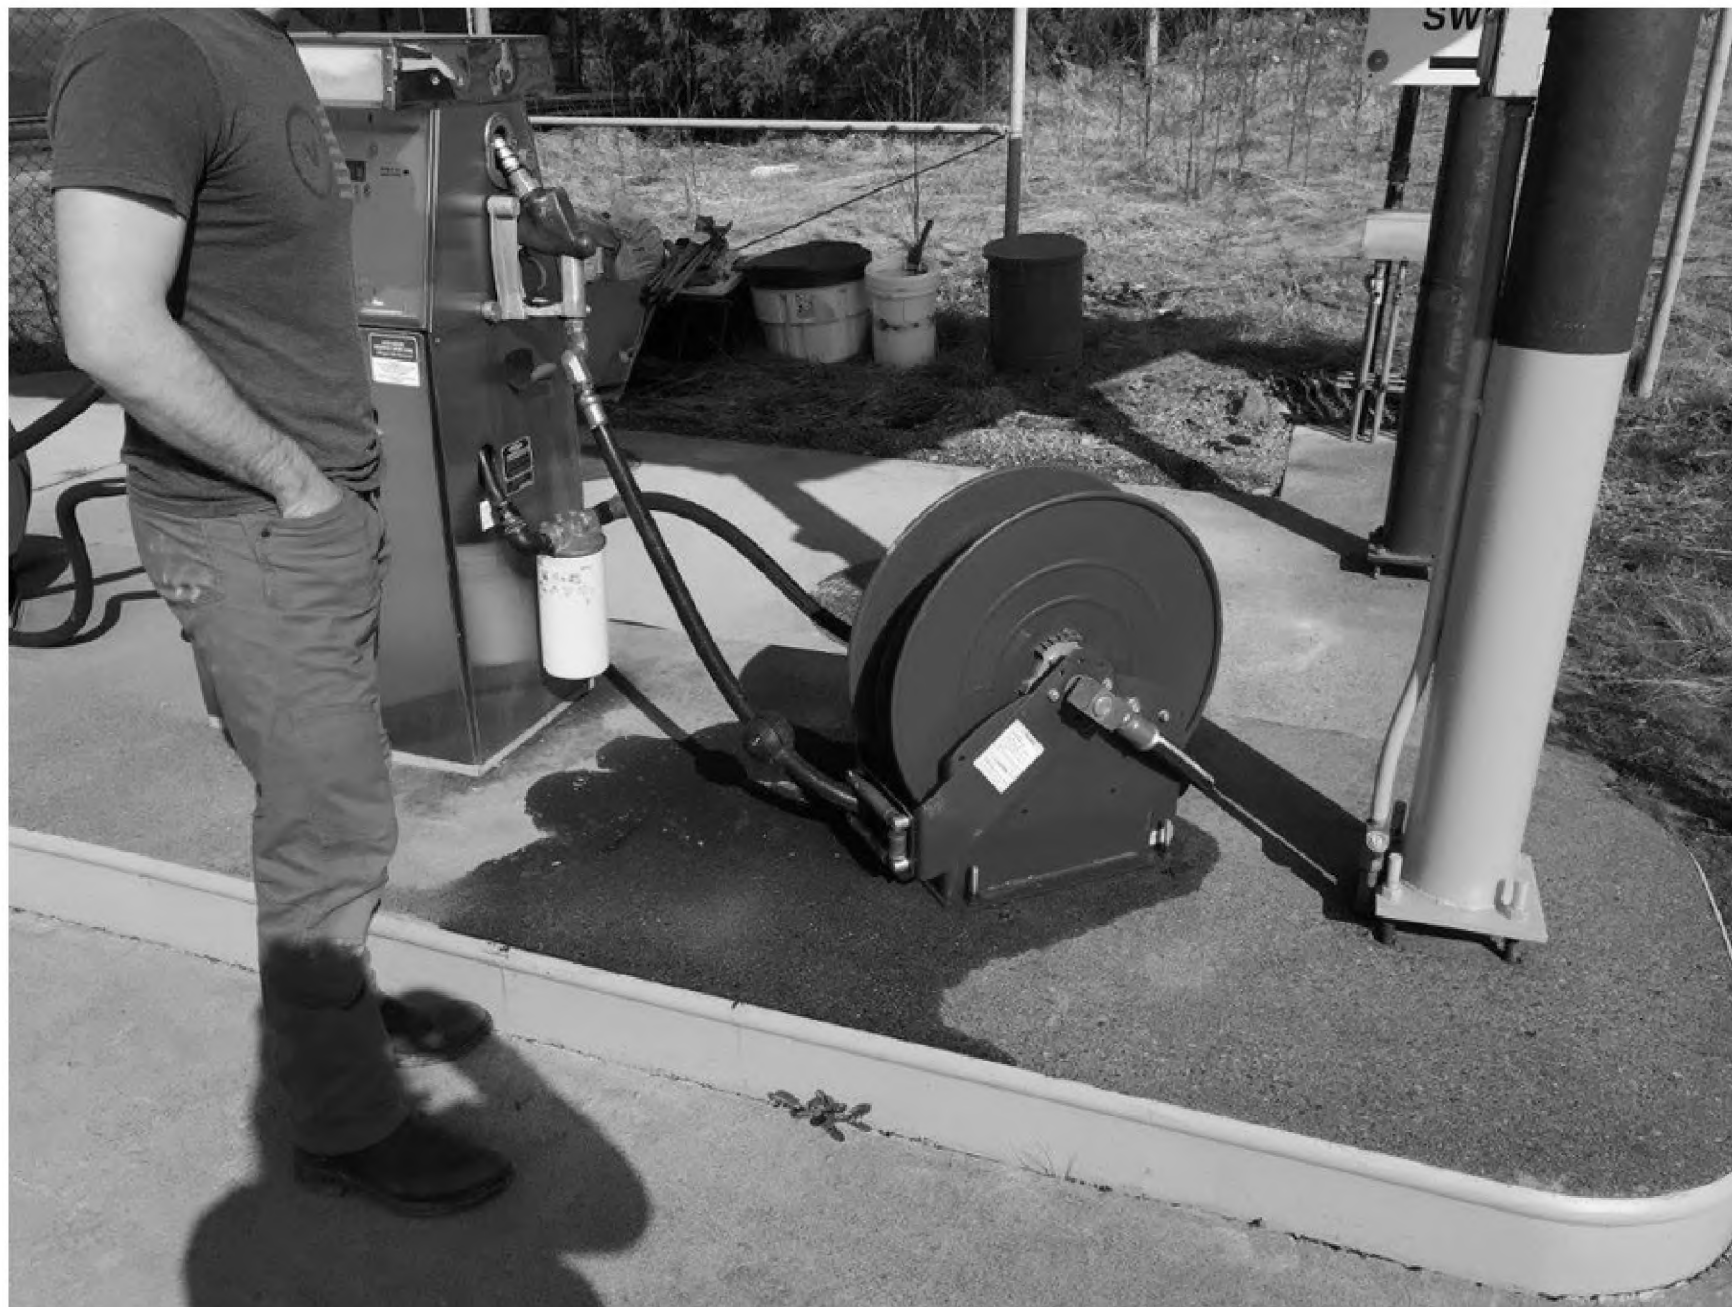
Photo 25

Photo Description: Forebay area - Maintenance shed fuel pump and Diesel leak/spillage

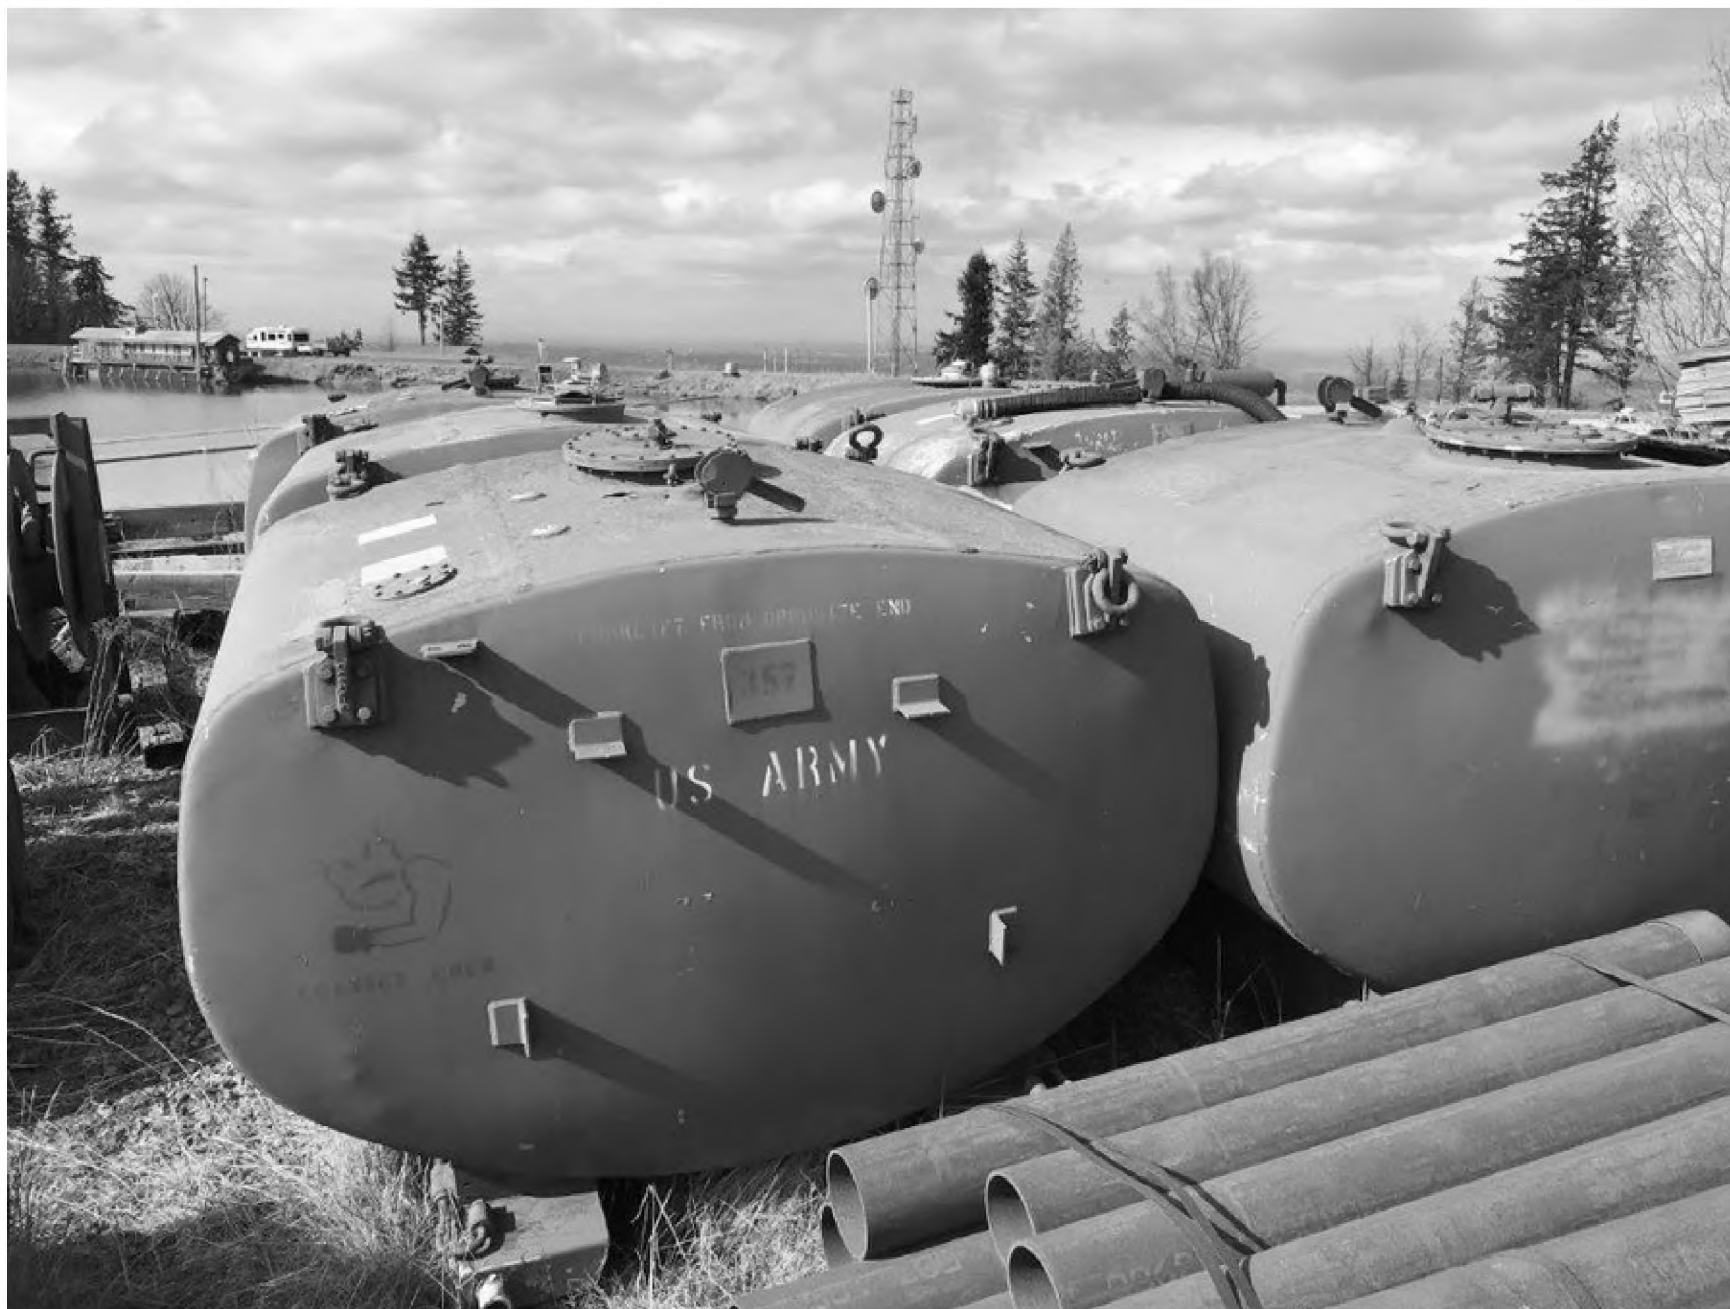
Photo 26

Photo Description: Forebay area – Old fuel storage tanks located in the laydown area.

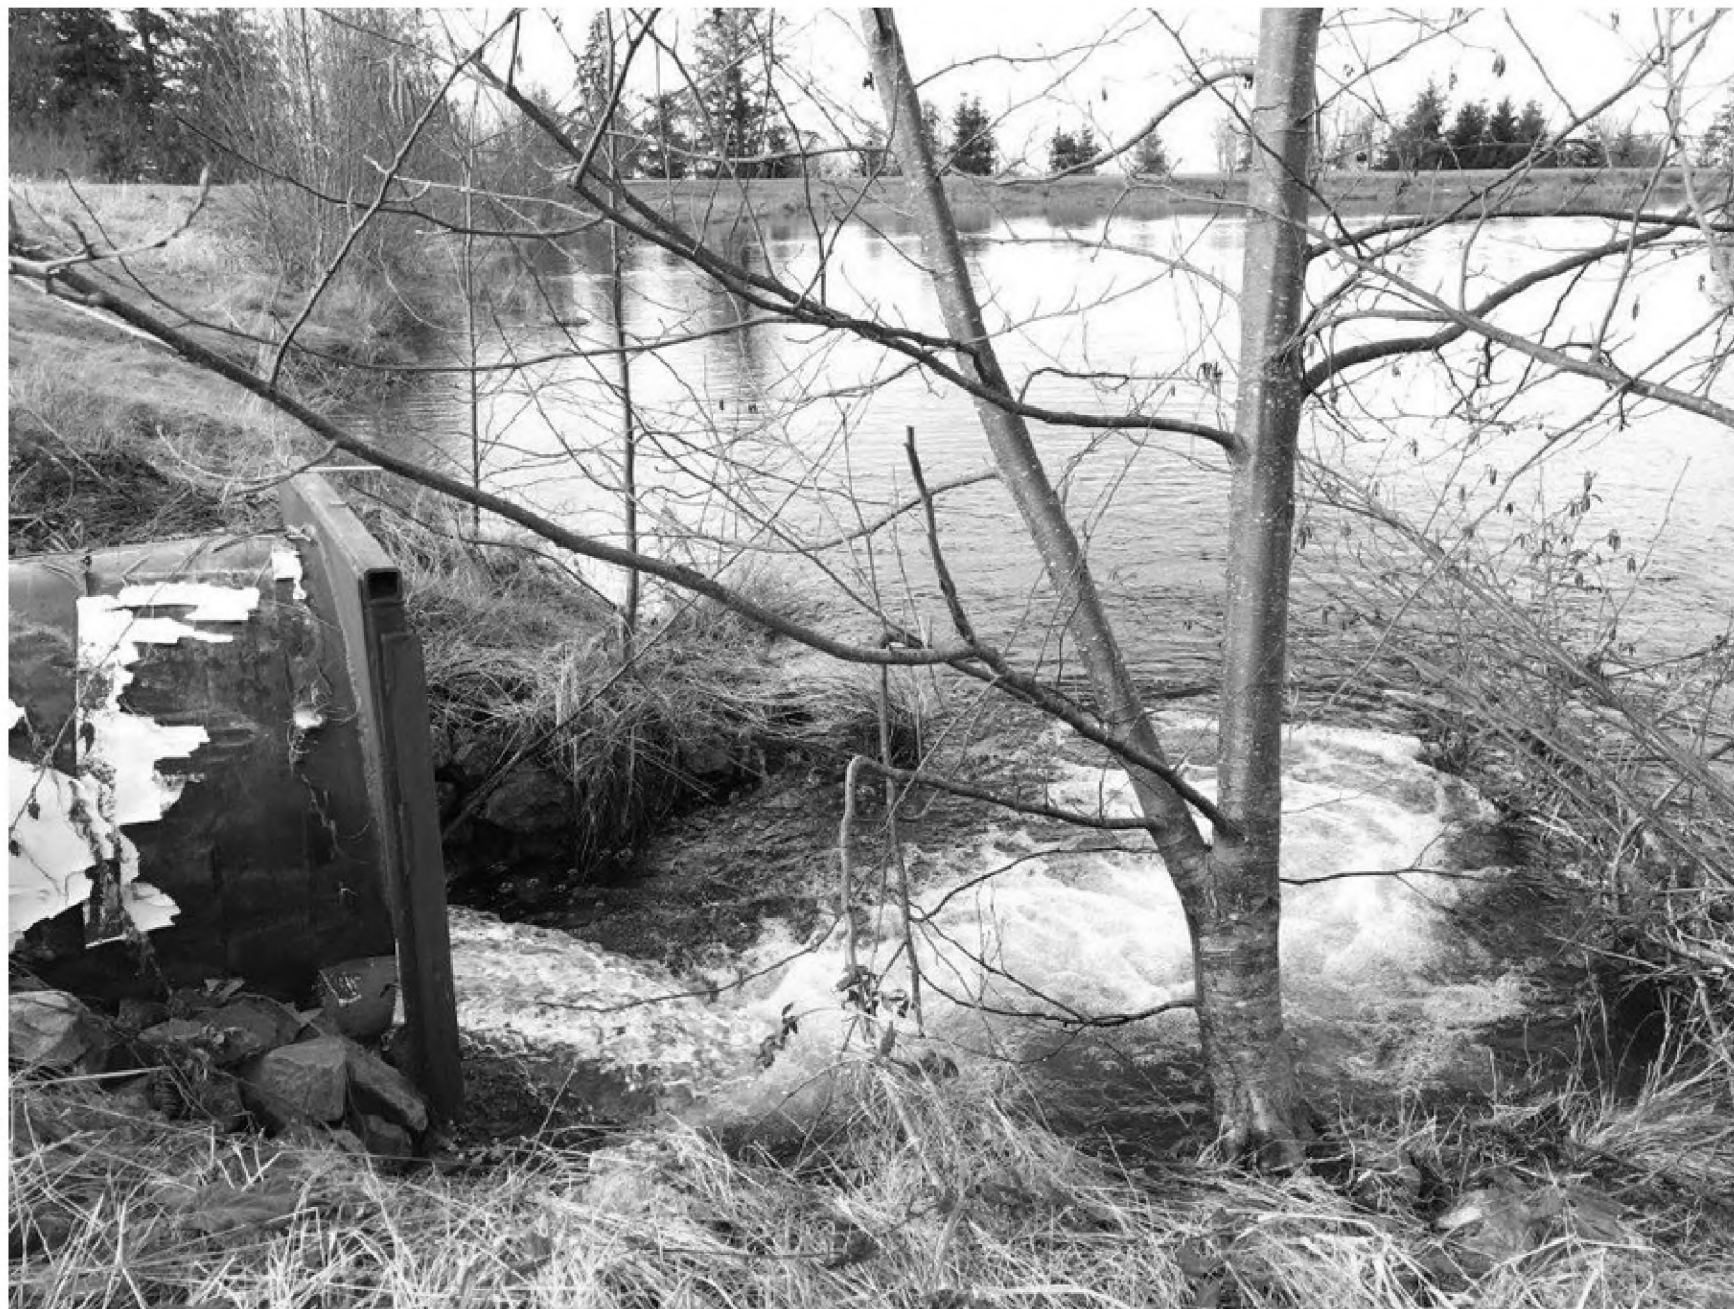
Photo 27

Photo Description: Forebay area - Tributary emptying into the forebay (this tributary was discussed as a possible temperature monitoring location).
